Inspection Report

RL Property Inspections

123 Townline Rd
Some Place 12345

Date: 2/13/2016	Time: 09:00 AM	Report ID: Sample Report
Property: 123 Townline Rd Some Place 12345	Customer: John Doe

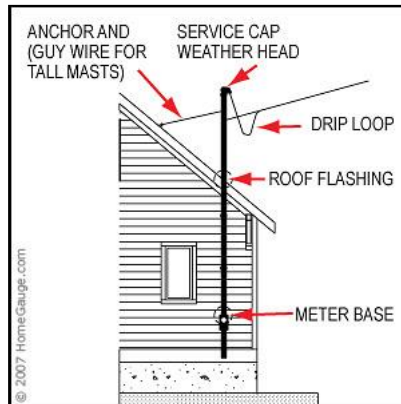
1.0 Graphics.

1.0 The exterior service drop conductor insulation, raceway, and meter panel are deteriorated, the electrical service is not fastened and is close to a window, and repairs by a qualified electrician are needed.

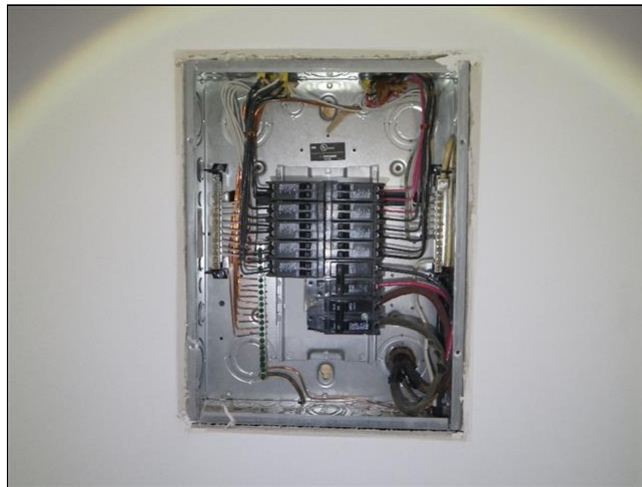
1.4 The panel board contains tandem breakers in locations not rated for them and further evaluation by a qualified electrician should be considered.

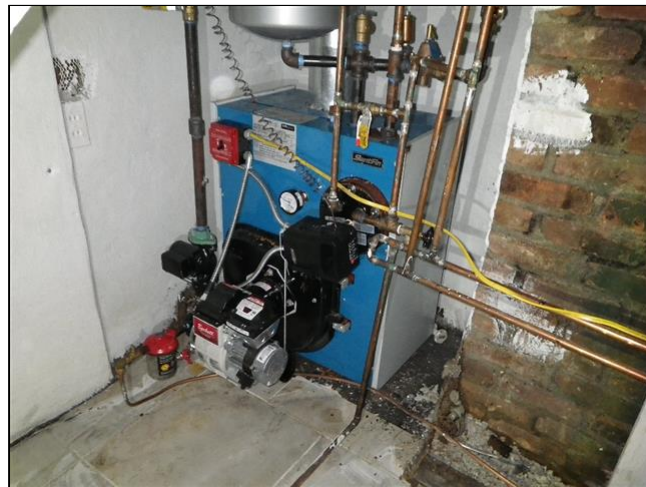
2.0 The heating system was shut down at the time of this inspection, the oil tank was empty, and having the system turned on prior to the final walk through to verify proper operation is needed. The boiler T / P relief valve extension tube is missing and the installation of one is needed for safety.

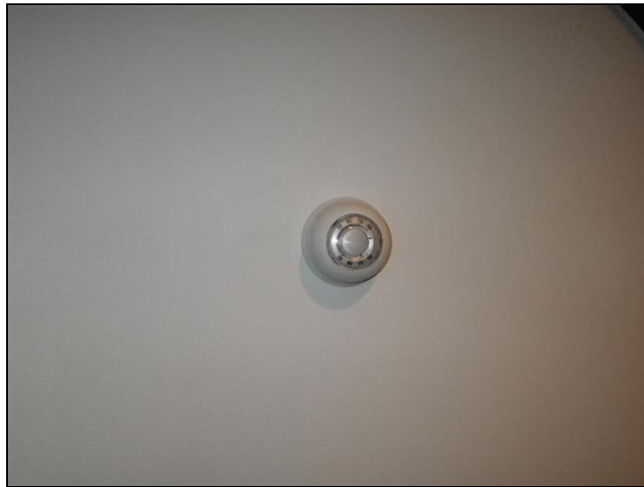
2.3 The heating system was shut down at the time of this inspection and it is recommended that the seller be notified to turn it on prior to the final walk through to verify proper operation.
